Manhole Inspection Summary

Manhole # S47K2_058MH

Record Plat: **47K2** Node: **058** Status: **New Manhole (Not in GIS)** Insp Date: **4/8/09 12:00 AM**

Location Address: **Ben Hill Ave**

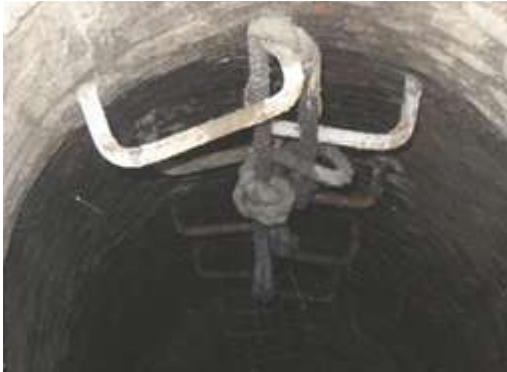
steps

Steps Count: **7** Missing: **0** ☐ Corroded

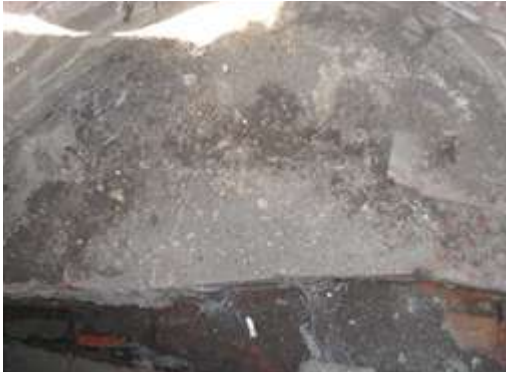
Defect 1

Slight debris on bench

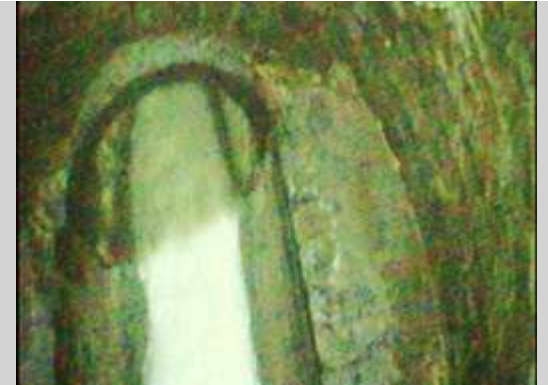
12 O'Clock Outflow

27 in. Circular Gravity Sewer
Pipe Out @ 12 O'Clock

Pipe Height: **26.4** (in.) Rod and Bar (Angled)
Pipe Material: **Concrete** ☐ Pipe Lined
Invert Depth: **24.45** (ft.) Flow Characteristics: **Fast**
Deposits: ☒ None ☐ Mud ☐ Sludge ☐ Debris ☐ Grease
Silt Depth: (in.) Deposits Extent:
Infiltration: **None** Pipe Seal Cond: **Sound**

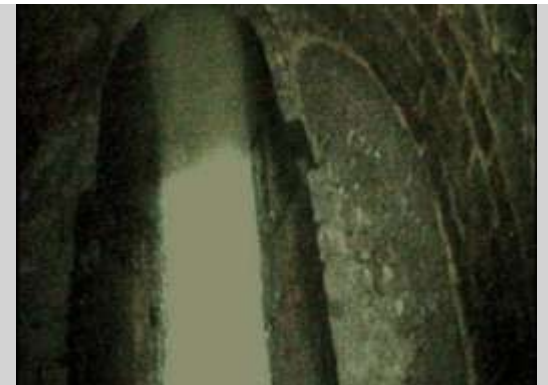
6 O'Clock Inflow

21 in. Circular Gravity Sewer
Pipe In @ 6 O'Clock

Pipe Height: **21.6** (in.) Rod and Bar (Angled)
Pipe Material: **Clay** ☐ Pipe Lined
Invert Depth: **23.90** (ft.) Flow Characteristics: **Fast**
Deposits: ☒ None ☐ Mud ☐ Sludge ☐ Debris ☐ Grease
Silt Depth: (in.) Deposits Extent:
Infiltration: **None** Pipe Seal Cond: **Sound**
